# Building Inspection Report

St. Louis, MO 63109

Prepared by: Wessling Home Inspection Services LLC  
5725 Holly Hills  
St. Louis, MO 63109  
314-520-1103

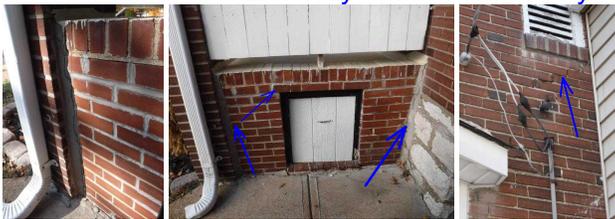
1. Marginal Type: Brick -  
 - Several stairstep separations and cracks have developed through the brickwork along the walls of the front porch, the west side front room windows, the west rear window and at the southwest corner of the home.

- This type of cracking could indicate building movement (especially when considered with the condition of the wall on the adjacent neighboring building) and/or issues with the brick archway at the window openings. Additional review and repair by a qualified masonry contractor/structural specialist is recommended prior to the close of your inspection period. At a minimum, the gaps in the mortar should be tuckpointed to prevent moisture entry and allow monitoring for any change in condition. Movement cannot be predicted or entirely prevented. A goal should be to maintain consistent soil moisture content around the home. Positive drainage should be provided, especially from along the west side where it appears moisture is puddling.

- Tuckpointing an entire home can be costly. Costs vary widely and usually are related to the preparatory work performed to provide a quality long-term result. When choosing a tuckpointer, be sure to understand whether the tuckpointer is grinding out all joints deeply to obtain a proper bond of the new mortar and if color matching is included in the work. The type of mortar should match that originally used for the home's construction (types include O, S, & M, which relate to the material mix and hardness/softness). Our experience is that the cheaper tuckpointers tend to smear thin layers of mortar over the joints, which may look good immediately but tends to become detached in a very short number of years. This type of tuckpointing should be avoided.

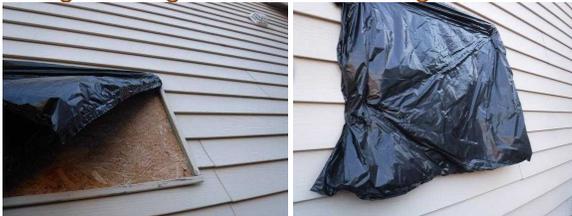
2. Minor Repair Type: Vinyl siding -

- Plastic covers an area along the west wall. A cut out in the siding is present. The reason is unknown to this inspector. Repair to install a weather resistant siding material properly flashed along the edges for a weather tight is recommended.

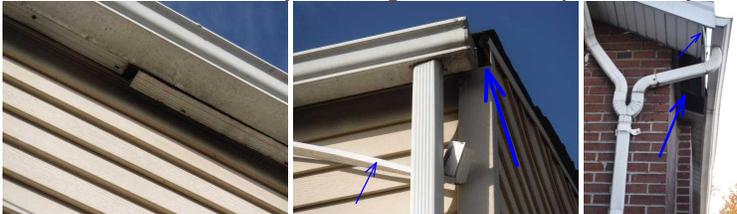
- 4. Minor Repair Soffits: Aluminum/Metal.  
 - Soffit material is loose/absent along several areas of the addition. Sections are loose around the main house. Some sections are absent near the rear corner of the main house. Nesting material is observed at the rear corner of the house. This inspector recommends replacing all absent soffit sections and securing any loose soffit against wind and animal related damages. Be sure to remove any nesting material as part of any soffit repair.

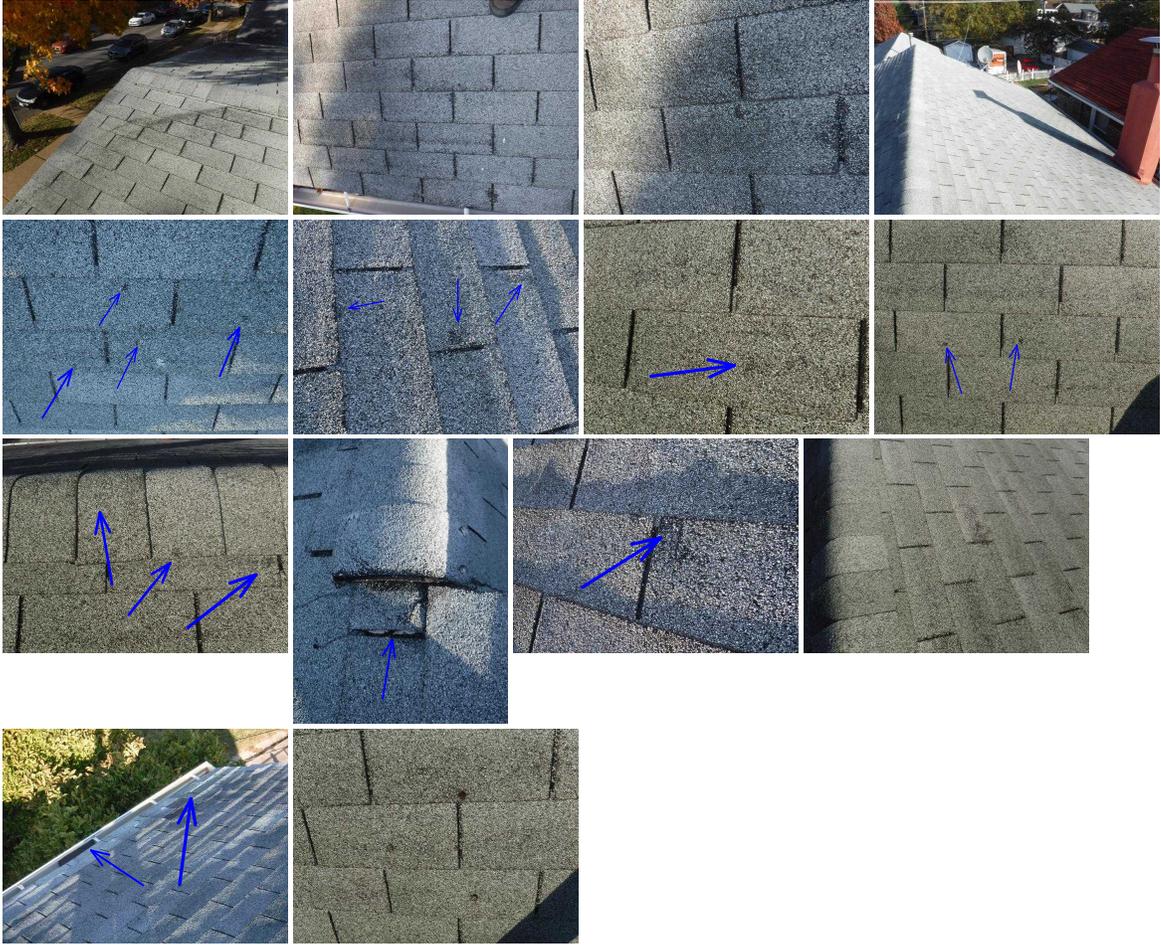
1. Method of Inspection: Walk on roof
  2. Marginal Material: 3 Tab fiberglass shingle - Blemishes are present that may be related to small hail damages or shingles damaged during application. Several depressions approximately the size of a nickel are present. Most merely impacted and bruised the outer shingle surface.

- Shingles are torn and damaged at the rear corner of the addition. Replacement of the damaged shingle is advised to prevent leakage into the structure.

- A small number of nails are raised, which can cause the overlying shingles to become punctured. Recommend driving down nails properly to prevent shingle damage. Several shingle have been damaged to the fiberglass mat and should be replaced to prevent further damage from the sun and possible moisture entry.

- The shingle have not been evenly spaces and woven together at the transition between the main house and the addition. The non-typical spacing between tabs increases the possibility of water leakage into the structure.

- Granular loss is observed in several areas. This indicates weather related wear or damage due to rubbing (front porch roof--tree branch) Anticipate the rate of deterioration to increase as the underlayment is exposed to the elements.

- Due to the issues above, this inspector recommends planning to replace this roof in the next few years.
  - The screws at the satellite dish penetrations need periodic maintenance to provide a water resistant surface and should be caulked as needed to prevent moisture entry.

- You may want to ask Seller, or your insurance company via a CLUE report, whether a claim for hail damage has ever been filed.
  - Consider having a qualified roofing contractor provide cost and repair/replacement options prior to the close of your inspection period.

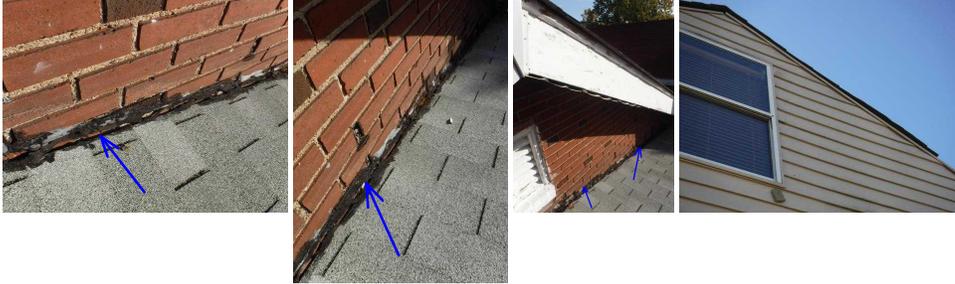
5. Minor Repair Flashing: Edge flashing is not present as desired - along the rear addition roof edges. Installation of edge flashing is recommended to help prevent water from wicking beneath the shingle and to direct the drainage of water out over the siding material.

- step flashing is required to prevent moisture entry where roof at an incline meets walls.
- step flashing should be installed according to the "Roofing and Waterproofing Manual" published by the National Roofing Contractors Association, the national trade group organization.
- Portions of the shingles will need to be removed in order to properly install step flashing. Due to the condition of the shingles, this work should be performed concurrently with the replacement of the roof.

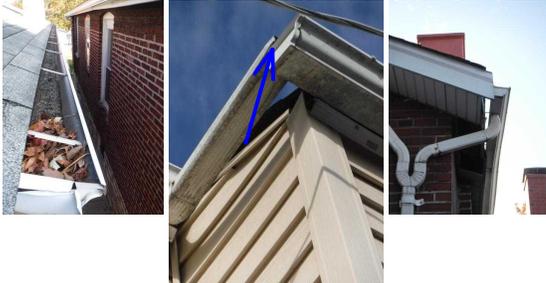
- the northwest gutter is loose and pulled away from the roof edge. Prompt repair is recommended to provide proper drainage of water out and away from the structure.

- Several gutter sections have negative slope and could hold water. Repair is recommended to provide secure gutters properly sloped for drainage.

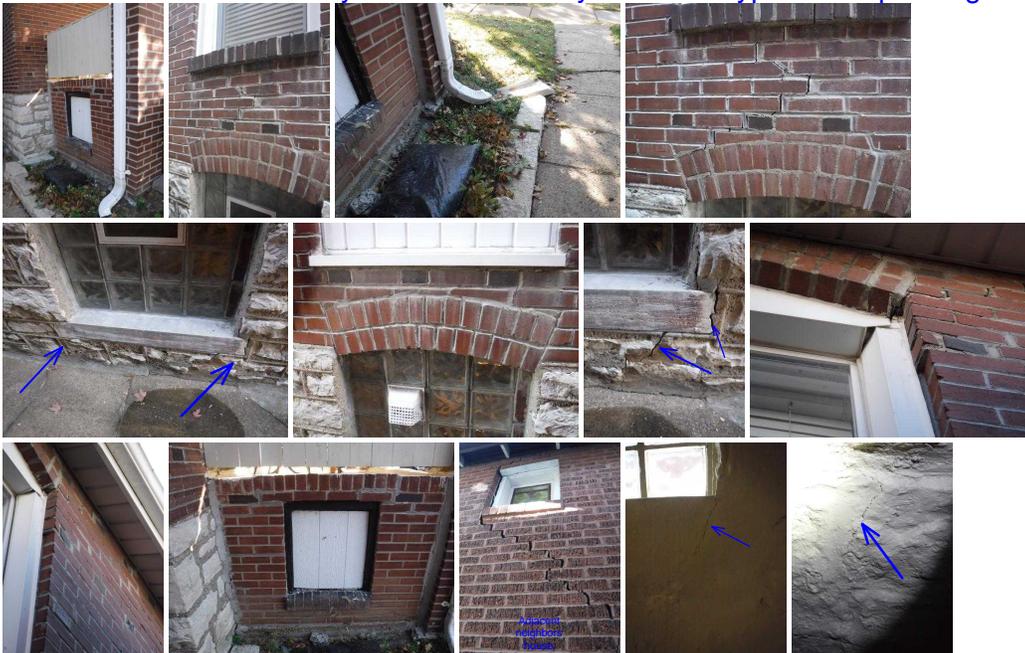
#### Foundation: Stone -

- Typical of old stone foundations and flat city lots, anticipate natural wicking of moisture through the stones. No active moisture entry was observed at the time of the inspection. It cannot be determined if moisture entry is an ongoing issue. The Sellers Disclosure Statement should be reviewed for any known moisture entry problems.

- Gaps and separations have developed through the stonework at the southwest corner of the home. This type of cracking could indicate building movement (especially when considered with the condition of the wall on the adjacent neighboring building). Additional review and repair by a qualified masonry contractor/structural specialist is recommended prior to the close of your inspection period. At a minimum, the gaps in the mortar should be tuckpointed to prevent moisture entry and allow monitoring for any change in condition. Movement cannot be predicted or entirely prevented. A goal should be to maintain consistent soil moisture content around the home. Positive drainage should be provided, especially from along the west side where it appears moisture is puddling.

- Spot tuckpointing can be performed and is recommended whenever and where ever gaps are observed to seal out moisture and prevent ice/water related damages.

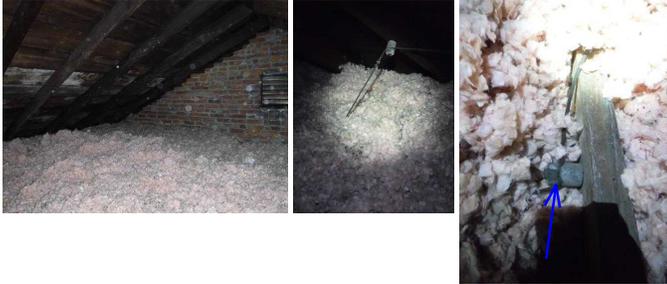
Insulation Depth: 8-10" avg Approx. Insulation Value: R-25+ -  
- Insulation has been improperly installed over knob and tube wiring. SEE ALSO ELECTRICAL--KNOB AND TUBE

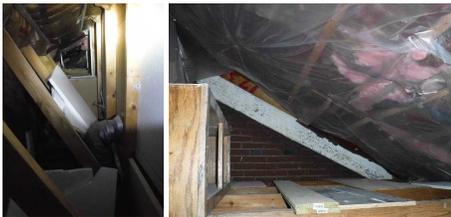
10. Not Inspected Unable to Inspect: EAST KNEEWALL SPACE, SPACE OVER LOFT -  
- no access provided for entry for this section of the attic.

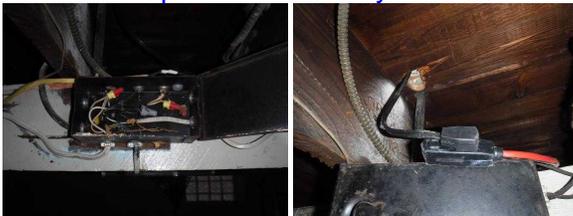
ON MAIN BEAM in basement Electric Panel

14. Marginal Panel wiring Improper wire entry at old enclosure now used as junction -  
 - cloth covered conductors and knob and tube type conductor enter through the same wire clamp/box knock out. This is not proper, knob and tube wire must enter from opposite sides of the box. Repair as necessary is advised.

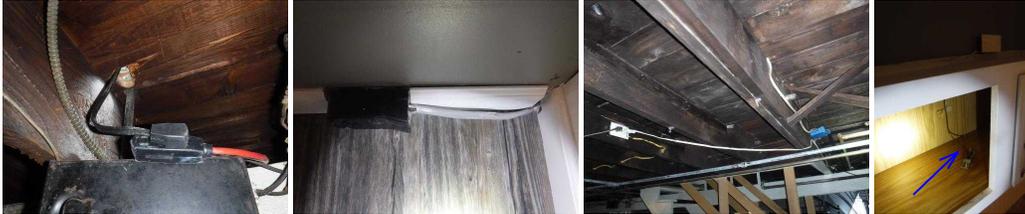
17. Safety Wiring Issues require proper repair - on ceiling in various locations and at the range receptacle should be corrected by rerouting the wires through the joists, running in conduit, or protecting by other allowed methods. Surface wiring of small gauge wires was never permitted as far as we are aware.

- Improper wire types used in the kitchen cabinets, window bay seating bench and basement. Lamp cord and extension cords have been used as permanent wiring. This is not proper. The lamp cord/extension cord should be replaced with the proper size of Romex type wire.

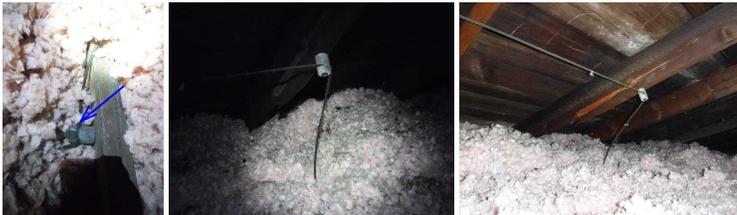
Knob & Tube Wiring Present in basement and attic -  
 - This wiring is covered with insulation and touching insulation. We recommend immediately removing all insulation, rewire the attic entirely, and replace the insulation. Knob and tube wiring must be exposed to 'open air' for proper dispersal of heat.  
 Unknown if other knob and tube wiring is present within the walls and ceilings. This old style of wiring has cloth or rubber sheath on the wires which becomes brittle with age and handling. There is an inherent risk of fire and electrocution if the wires become bare.

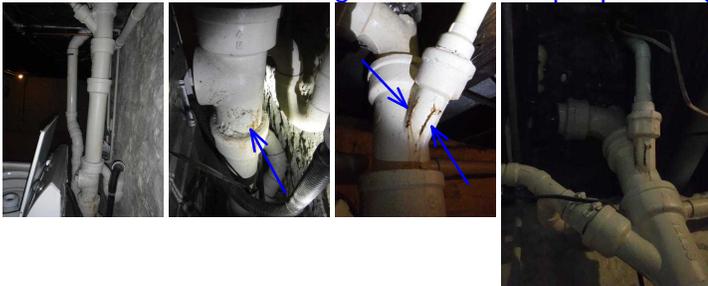
- Due to the deteriorated condition and age of the pipe we recommend that a licensed plumber replace all visible pipe in the 4" stack and connected branch line.

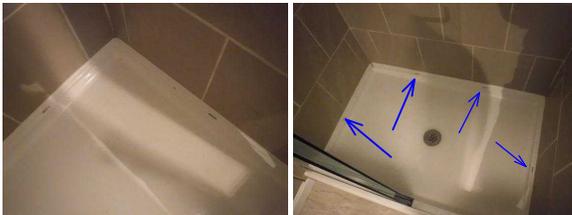
- 9. Acceptable Bathroom Bathroom fixtures performed as expected except as reported below
- 10. Marginal Bathroom FIRST FLOOR BATH: (ADDITION) - - Be sure to keep all joints in and near the tub, shower and sink sealed with a quality caulk to prevent water entry into the wall and floor cavity.

- Installation of shower pan is not standard. The weep ledge is visible, typically the weeps are positioned behind the surround surface to provide a drain for any seepage that may occur through the tile wall. Removal and replacement of the wall surface would be necessary to repair this issue.

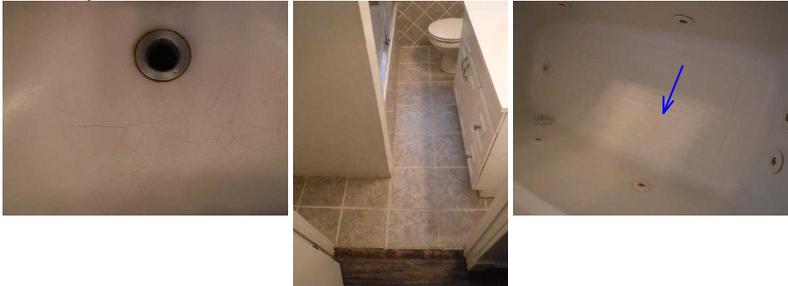
- Non-standard walking clearance in the bath area. This layout would not meet modern construction standards,

- Tile grout is cracked at shower wall near the window, likely permitting moisture entry into wall cavity with unknown related damage. Recommend remove tile, evaluate, repair as necessary, and replace tile.

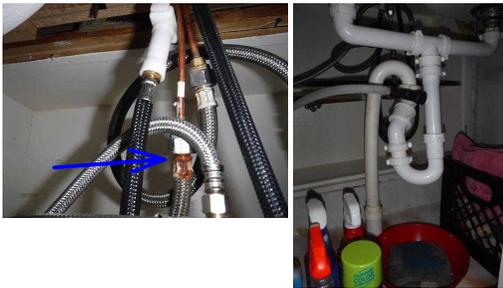
- 8. Acceptable Sink: Stainless Steel
- 9. Minor Repair Plumbing/Fixtures: Faucet & spray wand operated properly at time of inspection - - An "S" trap is present. These traps are subject to siphoning themselves dry, which would allow entry of sewer gases. An S-trap may not be permitted in this jurisdiction  
 - We recommend replacement with a proper P-trap.

- Dampness was observed on the center connection point on the faucet assembly. Repair as necessary is advised to prevent water damage to the home.

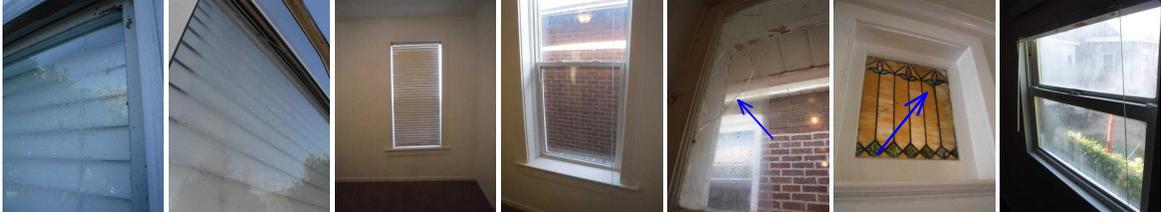
- The side front room window is not square in the opening, the wood frame is not square and plumb, the window sash is not square and plumb. One security latch is not able to be engaged on this window. This issue is likely related to the cracking observed in the brick wall around this window. Repair as necessary is advised for increased security and for proper window function.

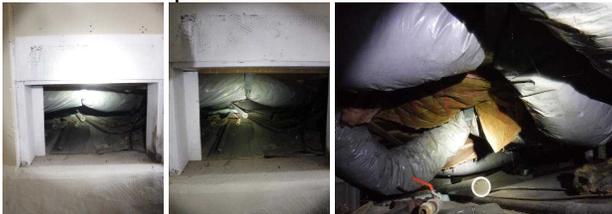
1. Method of Inspection: Viewed from access panel
2. Not Inspected Unable to Inspect: 90% due to lack of clearance -  
- HVAC duct prevented access

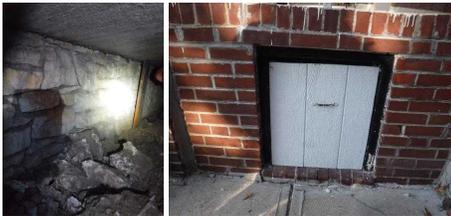
10. Minor Repair Moisture Barrier: No barrier was observed - - A plastic vapor barrier should be placed across the floor of the crawl space to minimize moisture entering the space from the soil. It is good practice to cover the vapor barrier with a layer of river gravel to prevent damage to the plastic from foot traffic.
