Building Inspection Report

St Louis Region
Missouri

Property Address Commercial Building
City St Louis Region State MO Zip 12346

Building Type Commercial/restaurant and store front Garage None
Additions/Modifications Modifications are observed, please consult with local authority for permits. Restaurant converted to office space

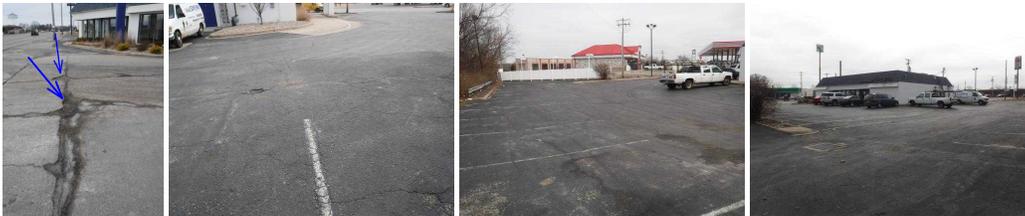
- Asphalt is displaying signs of age and surface is beginning to crack in a few areas. It remains flat and serviceable. Routine maintenance includes application of asphalt sealer periodically to provide a weather resistant surface. Some sections may require repair in the next few years by saw cutting around the area, removing the old asphalt, and layering in new asphalt to prevent additional damage to surrounding areas.

- Holes are present in the concrete apron approaching the street. This inspector recommends repair by concrete patching or filling with asphalt product to provide a smooth walking and driving surface.

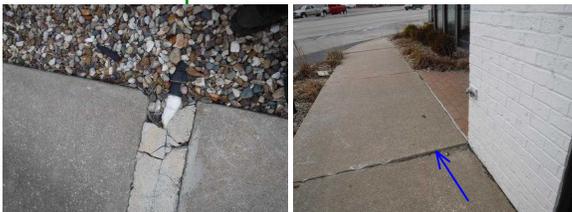
- One slab joint is uneven along the walk near the entry from the street side of the building (east). This poses a trip hazard. Slabs should be made even to prevent concerns with tripping (by mudjacking, physically leveling with sand, or replacing as needed).

- The concrete surface is breaking away above the downspout drain pipe, this is a tripping hazard and repair to the concrete surface is recommended

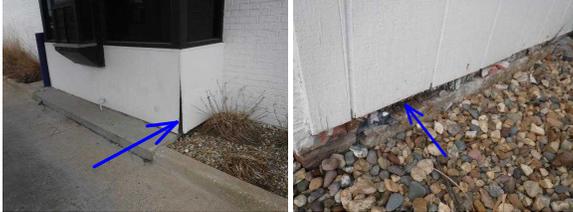
2. Minor Repair Type: Wood sheet siding -
- Overall, the siding looks in good condition.
- A small section of the underlying siding is deteriorated along the drive thru bay wall. The siding was easily pierced with a probe, however the probe did not penetrate into the sill plate. It is likely this was the original wood siding that was left in place when the new siding was installed.
- The corner seam is gapped. Repair to provide a properly sealed corner joint is recommended.

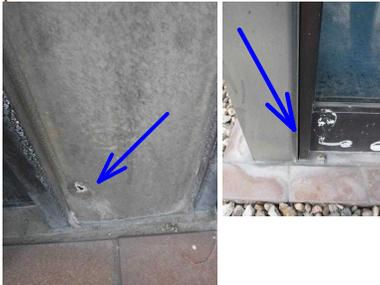
- Front corner trim near the drive thru is loose, caulk seam is open. Securing the open joint with matching caulk is recommended to prevent water and wind related damages.

- Some trim between glass sections is beginning to deteriorate/wear thin. Likely due to exposure from ice melting products and over spray from the road/sidewalk. Sealing with a matching caulk will help slow the deterioration, however, the only true repair would be to replace the affected areas.

- Be sure to maintain the exterior by keeping joints caulked and exposed surfaces liberally painted to avoid moisture damage.

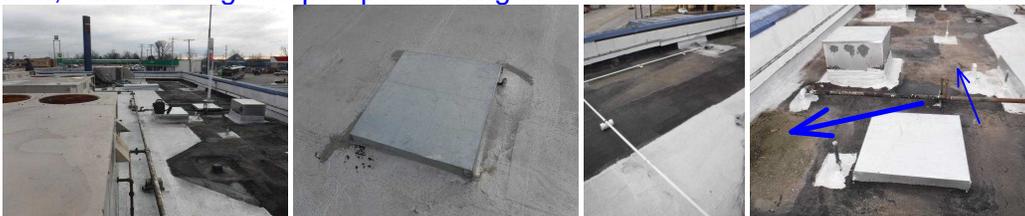
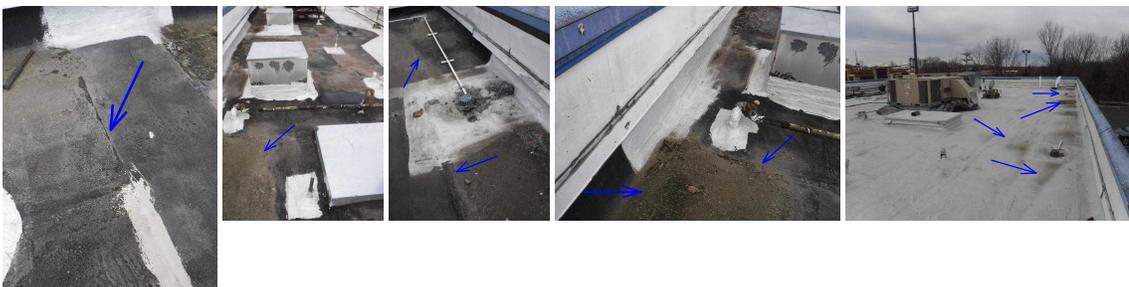
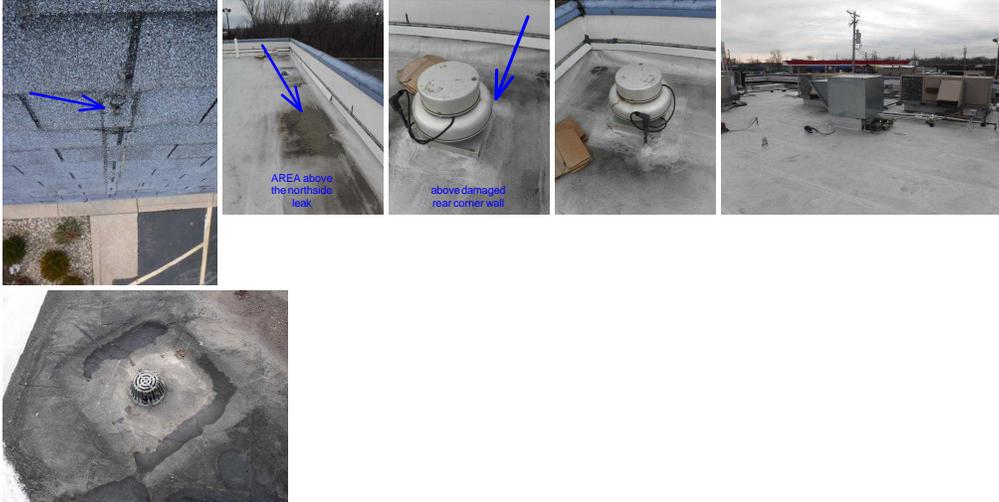
- Dips and Soft areas are felt when walking the roof, this can indicate moisture is present in the underlying layers of material. Stains and debris from pooling water are present near the ladder access and along the side wall parapets. This is not desirable as the roof surface will deteriorate more rapidly if not allowed to dry and the accumulated water weight could result in roof damage. Repair to prevent water pooling and promote drainage off the roof is advised. (This would also involve repair to the condensate drain to carry condensation off and away from the roof)

- A leak is suspected in the roof surface about mid way along the north wall. No flashing is located in this area, water stains are noted on the ceiling tile and the roof sheathing. The stains run along a plywood joint.

- We recommend sealing the damaged/split/gapped areas at the material joints, along the side parapet, at the pitch pots, and HVAC and other roof curbs to provide a water resistant surface.

- This inspector recommends a qualified roofing contractor apply a new surface coating over the roof, curb flashing and parapet flashing areas to ensure a water resistant surface.

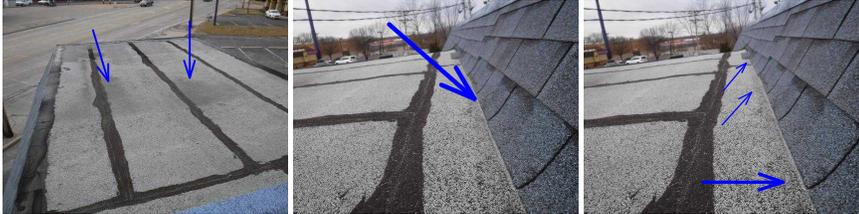
5. Minor Repair Material: Rolled granulated roofing - - Dips and Soft areas are felt when walking the roof, this can indicate moisture is present in the underlying layers of material. Stained and dirty areas are present, this indicates water is pooling on the roof surface. Pooling stains are present near the center of the roof. This is not desirable as the roof surface will deteriorate more rapidly if not allowed to dry and the accumulated water weight could result in roof damage. Repair to prevent water pooling and promote drainage off the roof is advised.

- This inspector recommends a qualified roofing contractor review the junction between the mansard and the drive-thru roof to ensure the flashing is water tight. A negative flow and small channel area are present along this junction. Damaged roof sheathing is observed in this area from leakage. It can not be determined if this is a past problem that has been repaired or is a current issue requiring repair. (Inspection was performed in dry weather)

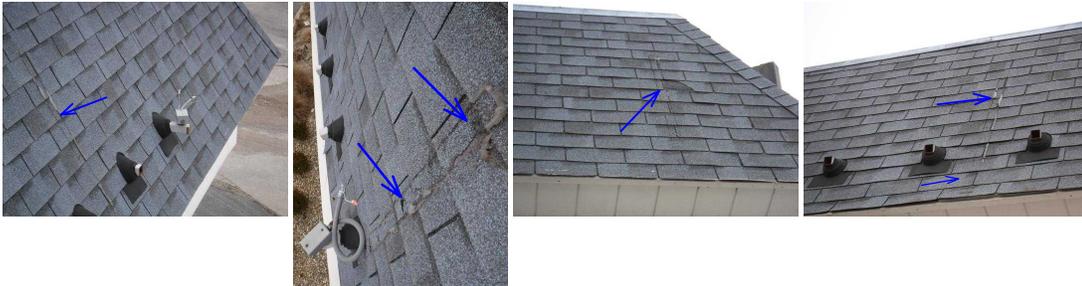
- Shingle damage is present where old business signs were mounted, some shingle is torn, some surface is pulled away down to the underlying fiberglass matt. The damaged shingle tabs could be replaced if matching shingle is available. At a minimum, the damaged areas should be sealed with a clear or colored matched mastic or high quality caulk to provide a water resistant surface.

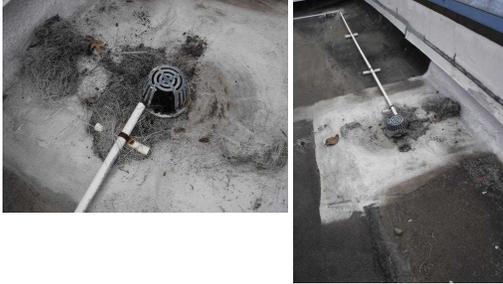
- Repair to ensure a proper water seal is present is advised. Staining was observed in the roof sheathing around the roof drains.

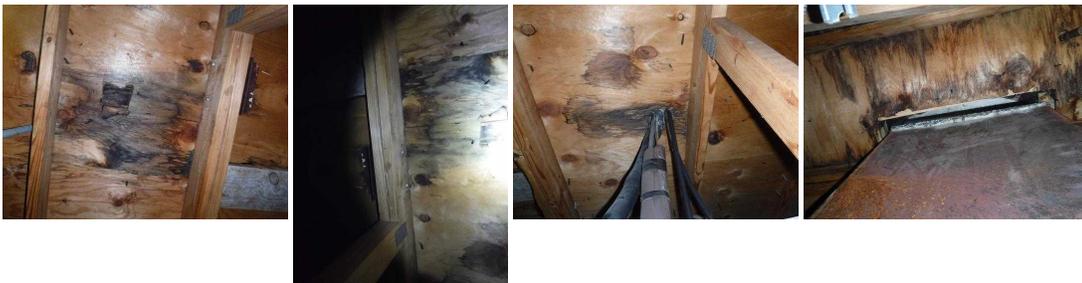
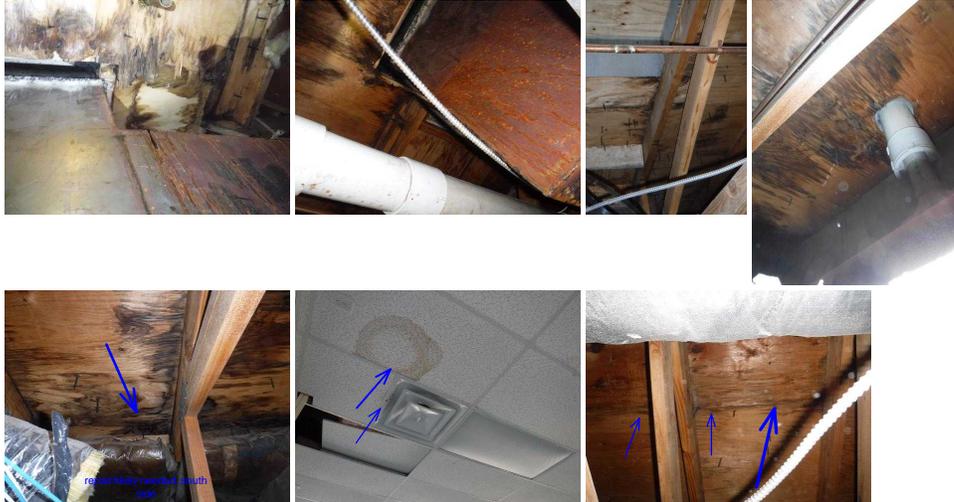
6. Minor Repair Roof Sheathing: Plywood.
- Dark moisture stains are visible in attic along the drive-thru connection to the main roof. A small section of the sheathing is deteriorated. This area should be reviewed for any necessary repair to prevent additional deterioration of the sheathing. Typically, this type of damaged sheathing would be replaced when a new roof surface is installed.

- Numerous stains are visible in the areas of the HVAC curb, old ventilation locations and below 'pitch pots' for entry of service lines into the building from the HVAC and other roof items (old refrigeration compressor, old locations of original HVAC equipment, exhaust vents etc). It is unknown if moisture entry is an ongoing or historical issue that has been corrected. Be sure to monitor these areas for any darkening or enlargement of the stains or of moisture. If any changes are observed, seek repair by a quality roofing contractor to help prevent additional damages.

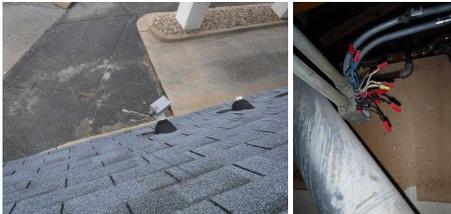
- near any water source and/or counter
12. Acceptable Outlet All tested properly wired
13. Minor Repair Wiring Issues require proper repair -
in attic space should be properly secured to prevent stress on the wires and damage from vibrations. Many wire runs are loose hanging without proper support.
14. Minor Repair Cover Plates Absent:
from several boxes and lamp connections in the attic space.

- "Pig tails" with capped, but unsecured wire ends are present on the exterior of the building where signs were previously located.

Installation of proper covers and junction boxes is advised.

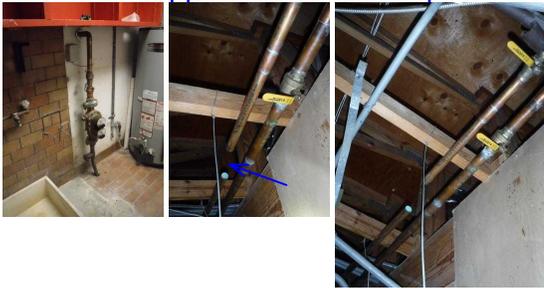
- 1. Marginal Water Pipe Materials: Copper.
 - Several pipe runs are cut above the ceiling tile, pipe is open ended. At a minimum, these pipes should be capped and sealed to prevent water leakage through the service valves.

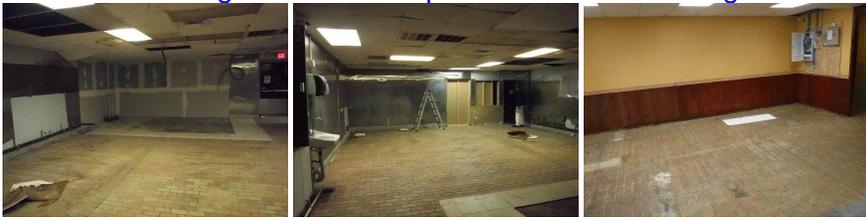
1. Marginal Floor: Carpet. Ceramic/Stone.
 - Some unevenness is present from past repairs, renovations, and layers of ceramic tile.
 - Marked as marginal due to the potential cost of leveling the floor.

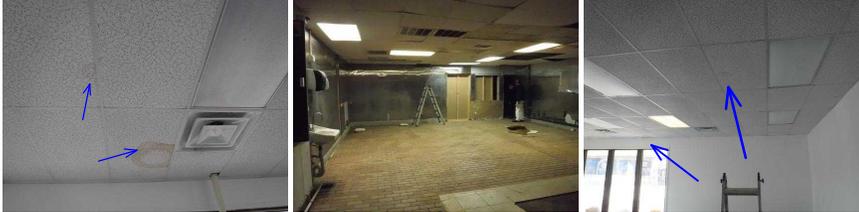
2. Minor Repair Ceilings: Drywall. Drop Ceiling Grid.
 - Drywall ceiling in the bath and drive-thru areas. Some areas of peeling paint and damaged ceiling surface are present in the bathrooms. These areas could easily be repaired by a painting contractor or quality handyman.
 - Ceiling tile are stained throughout the building. Most of the stained areas are below roof penetrations for the HVAC, service lines, old exhaust equipment, and roof drains. The tile could easily be repaired or replaced after the roof has been repaired to prevent water seepage. (SEE ALSO ROOF--SURFACE)

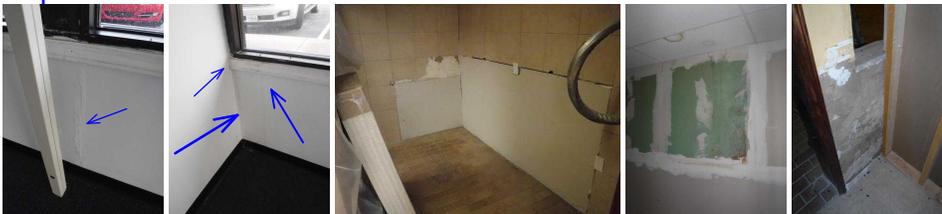
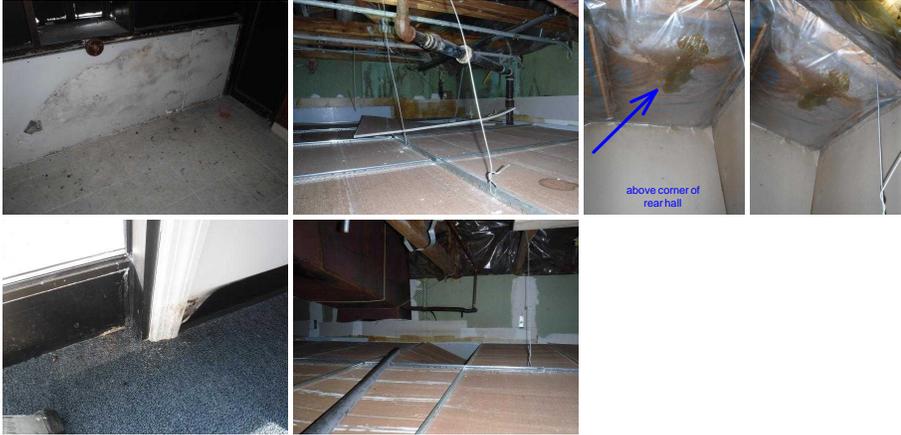
- A small area at the base of the south window is moisture damaged, the paint on the wood trim is blistered, dark stains are visible behind the corner of the cove base which is no longer secured to the wall. Removal of this small area of drywall may be desired to ensure all potential leak points from the window framing have been sealed against moisture entry.

- Drive-thru The lower exterior wall area is stained. Likely from moisture exposure. A portion of the drywall has been replaced, dark shadows are observed. Staining is observed on the upper aluminum frame of the window bay. Further evaluation is recommended (including removal of drywall and finish materials) to identify areas requiring repair. (SEE ALSO ROOF SECTION)

- Hallway to rear kitchen, the lower section of drywall has been replaced, ceramic tile is absent. Two potential areas of concern are present that may have been the source of water damages to this area. 1) the wall is common to the ladies room, overflows may have occurred in the past. 2) the roof, the area is near the parapet, the plumbing stack and the bath exhaust. The plastic sheeting placed in this area is stained and sagging indicating water has been present at some point in the past. (SEE ALSO ROOF SECTION) This inspector recommends replacement of any water damaged drywall and insulation.

- North wall below the windows, pulled/popped/blistered paint and drywall tape, stains are present in the corner. Damage observed is consistent with water damage/exposure to moisture. Further evaluation, including removal of some drywall will be necessary to identify necessary repair.
