Building Inspection Report

St Louis Region
Missouri

Property Address Commercial Building
City St Louis Region State MO Zip 12346

Building Type Commercial/restaurant and store front Garage None
Additions/Modifications Modifications are observed, please consult with local authority for permits. Restaurant converted to office space

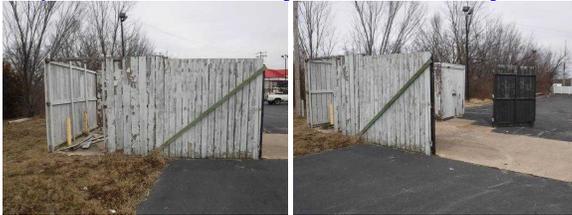
4. Acceptable Grading: Appears appropriate along majority of foundation, Flat City lot
5. Minor Repair Vegetation: Bushes, small trees and shrubs -
- should be maintained to prevent growing against the sides of the building, which can damage the mortar and siding surfaces
6. Marginal Fences: Dumpster area fencing.
- The wood pickets are broken and deteriorated on both the fence and storage shed.
Replacement will likely be a necessary municipal requirement.

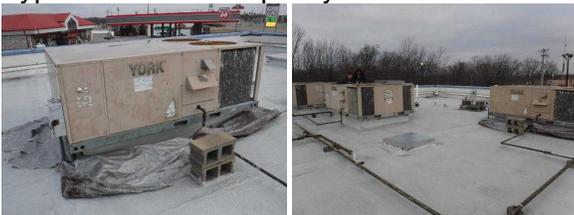
2. Acceptable Combustion Air Appears adequate with exterior air
3. Manufacturer: Four YORK Roof Top Units are Present.
4. Type: Forced air Capacity: Each Unit is rated for 161,500 BTUHR

5. Fuel Type: Natural gas
6. Unable to Inspect: 80%
7. Acceptable Filter Size:
16x24x2
8. Acceptable Filter Type: Disposable
- Filters in the old kitchen area were grease coated and clogged. The filters were allowed to fall to the floor due to the saturated condition. The grates are also grease covered. Replacement of the filters and grates is necessary.
